Geotechnical Investigation and Geological Hazards Study

GEOTECHNICAL-INVESTIGATION AND GEOLOGIC-HAZARDS STUDY  
MORAGA ROAD STORAGE  
2600 MORAGA ROAD STREET  
SAN PABLO, CALIFORNIA

August 28, 2020  
2388-5A, L-32151

RE: Geotechnical-Studies and Fault-Hazard Investigation  
Moraga Road Storage  
San Pablo, California

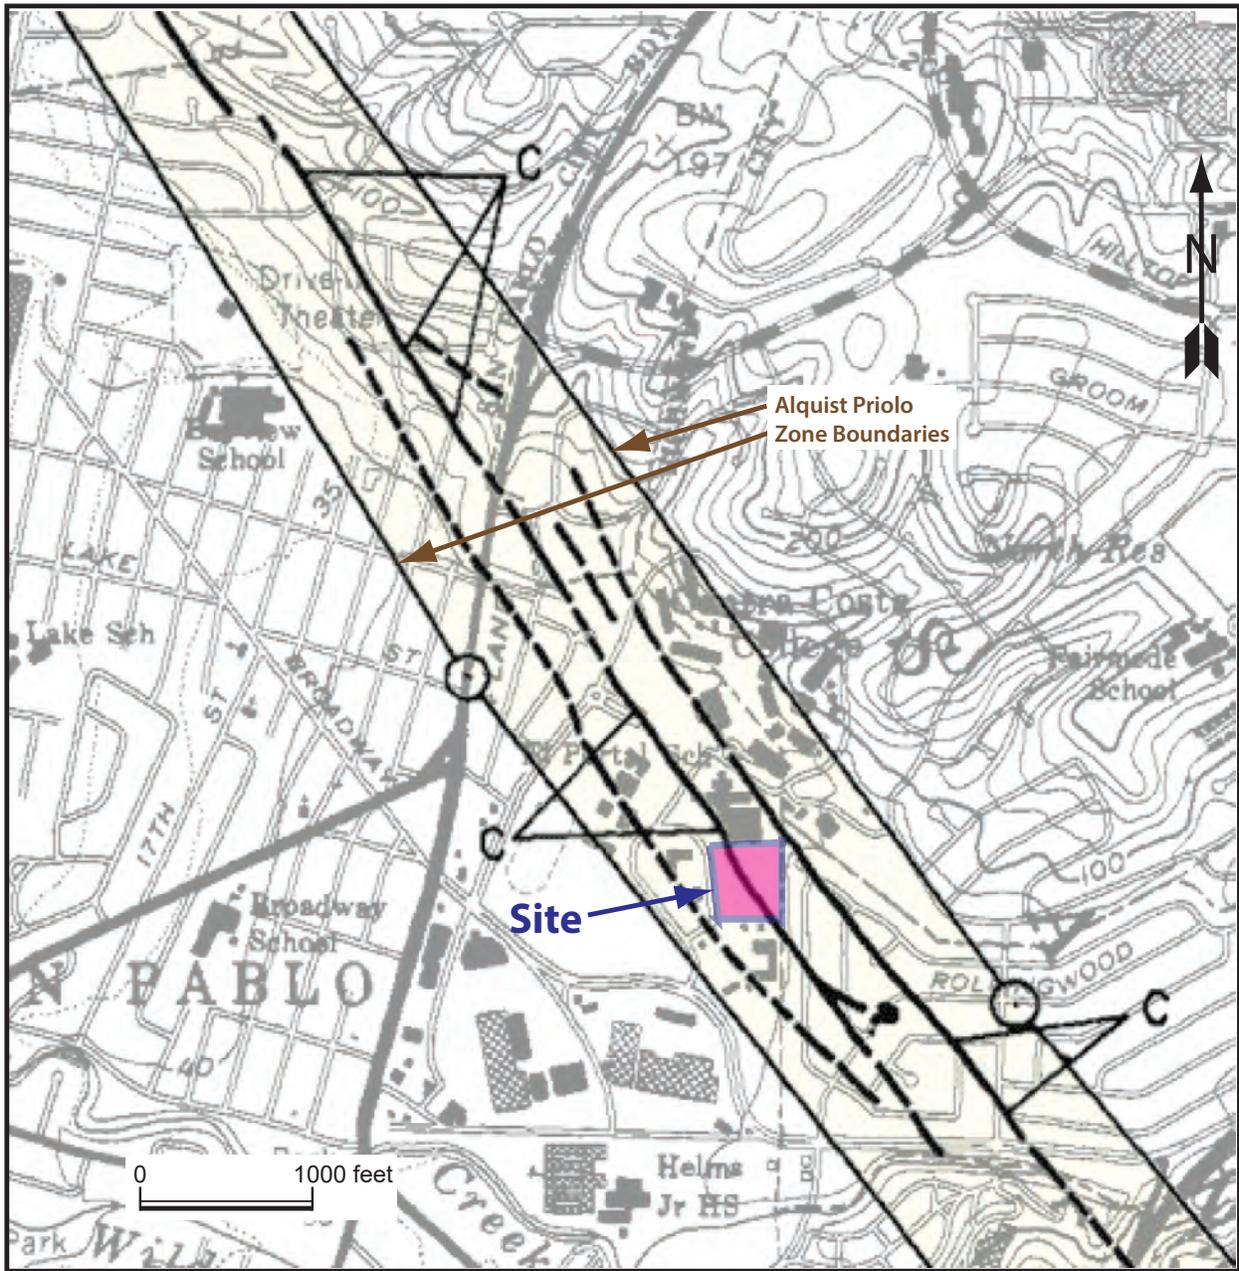
FIGURE **4**

The Alquist-Priolo Earthquake Fault Zone map (CDMG, 1982), which was based on the work of Smith (1980), shows three fault traces in the immediate site vicinity. A portion of that map is shown on Figure 4. Areas of observed creep are shown northwest and southeast of the subject site in the same areas shown by Lienkaemper (Figure 5). Fault traces are shown passing through the central portion of the subject site and near the eastern corner of this site, in general accordance with both Lienkaemper (1992) and Lettis (2003). An additional possible fault trace is shown a short distance west of the southwest corner of the subject site.

Radbruch (1974) prepared a map of the Hayward-Rodgers Creek fault zone. That map shows two traces of the Hayward-Rodgers Creek fault corresponding to the eastern and western traces mapped by CDMG (1982), as shown on Figure 4; however, the central fault trace passing through the middle of the subject site is not shown.

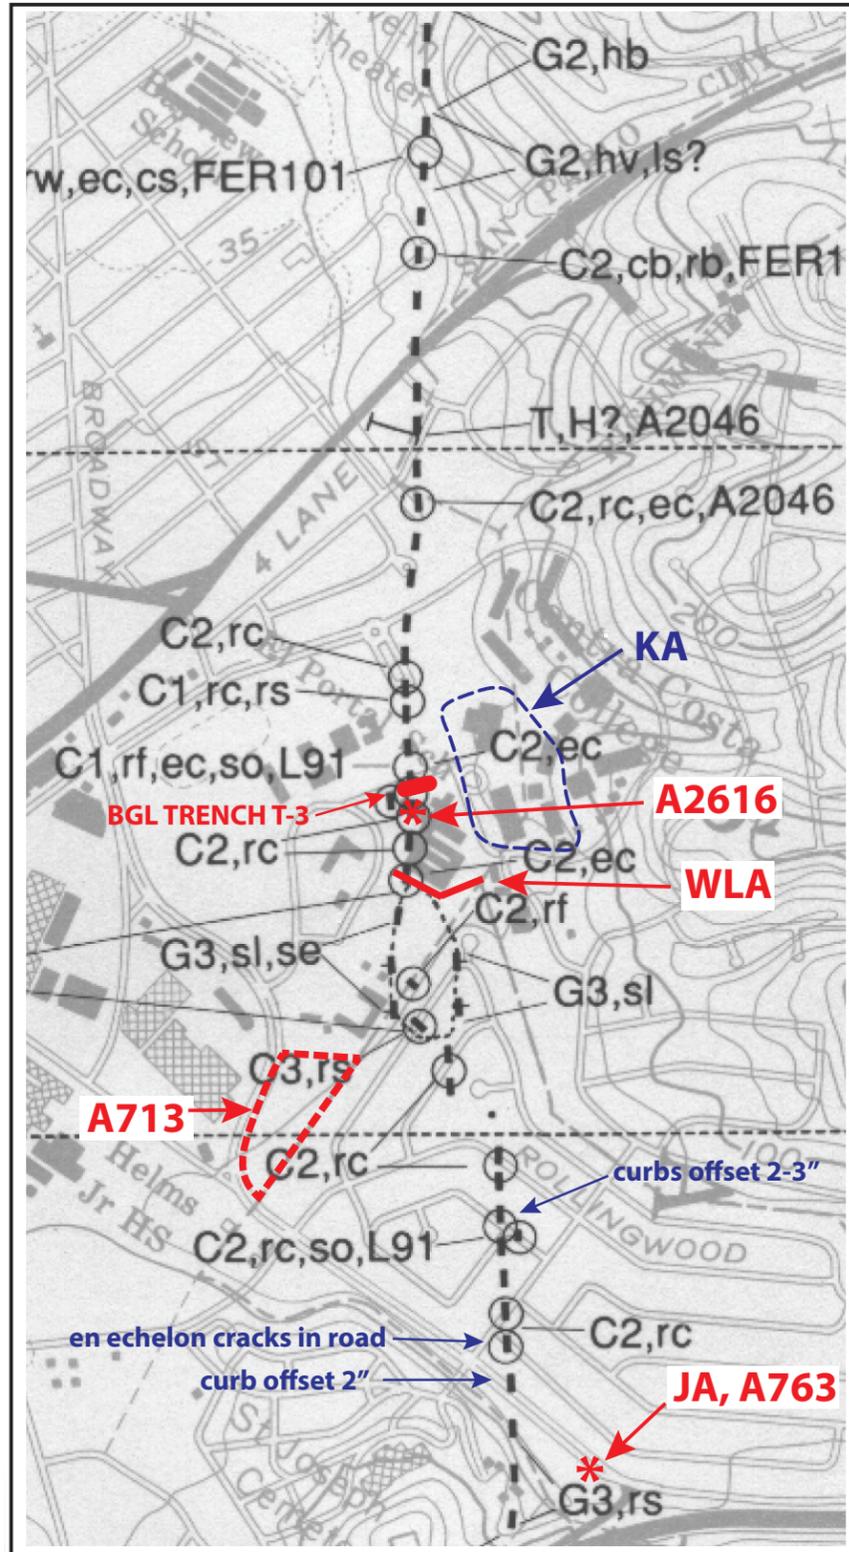
FIGURE 5

Lienkaemper (1992) prepared a map of active fault traces along the Hayward-Rodgers Creek fault. A portion of that map is reproduced on Figure 5. The Lienkaemper map was based on extensive remapping and aerial-photo interpretation, as well as review of available consultant reports. Lienkaemper shows two active traces of the Hayward-Rodgers Creek fault crossing the subject site (Figure 5). The traces mapped by Lienkaemper correspond with several locations where evidence of faulting or geomorphic features suggestive of faulting were observed.

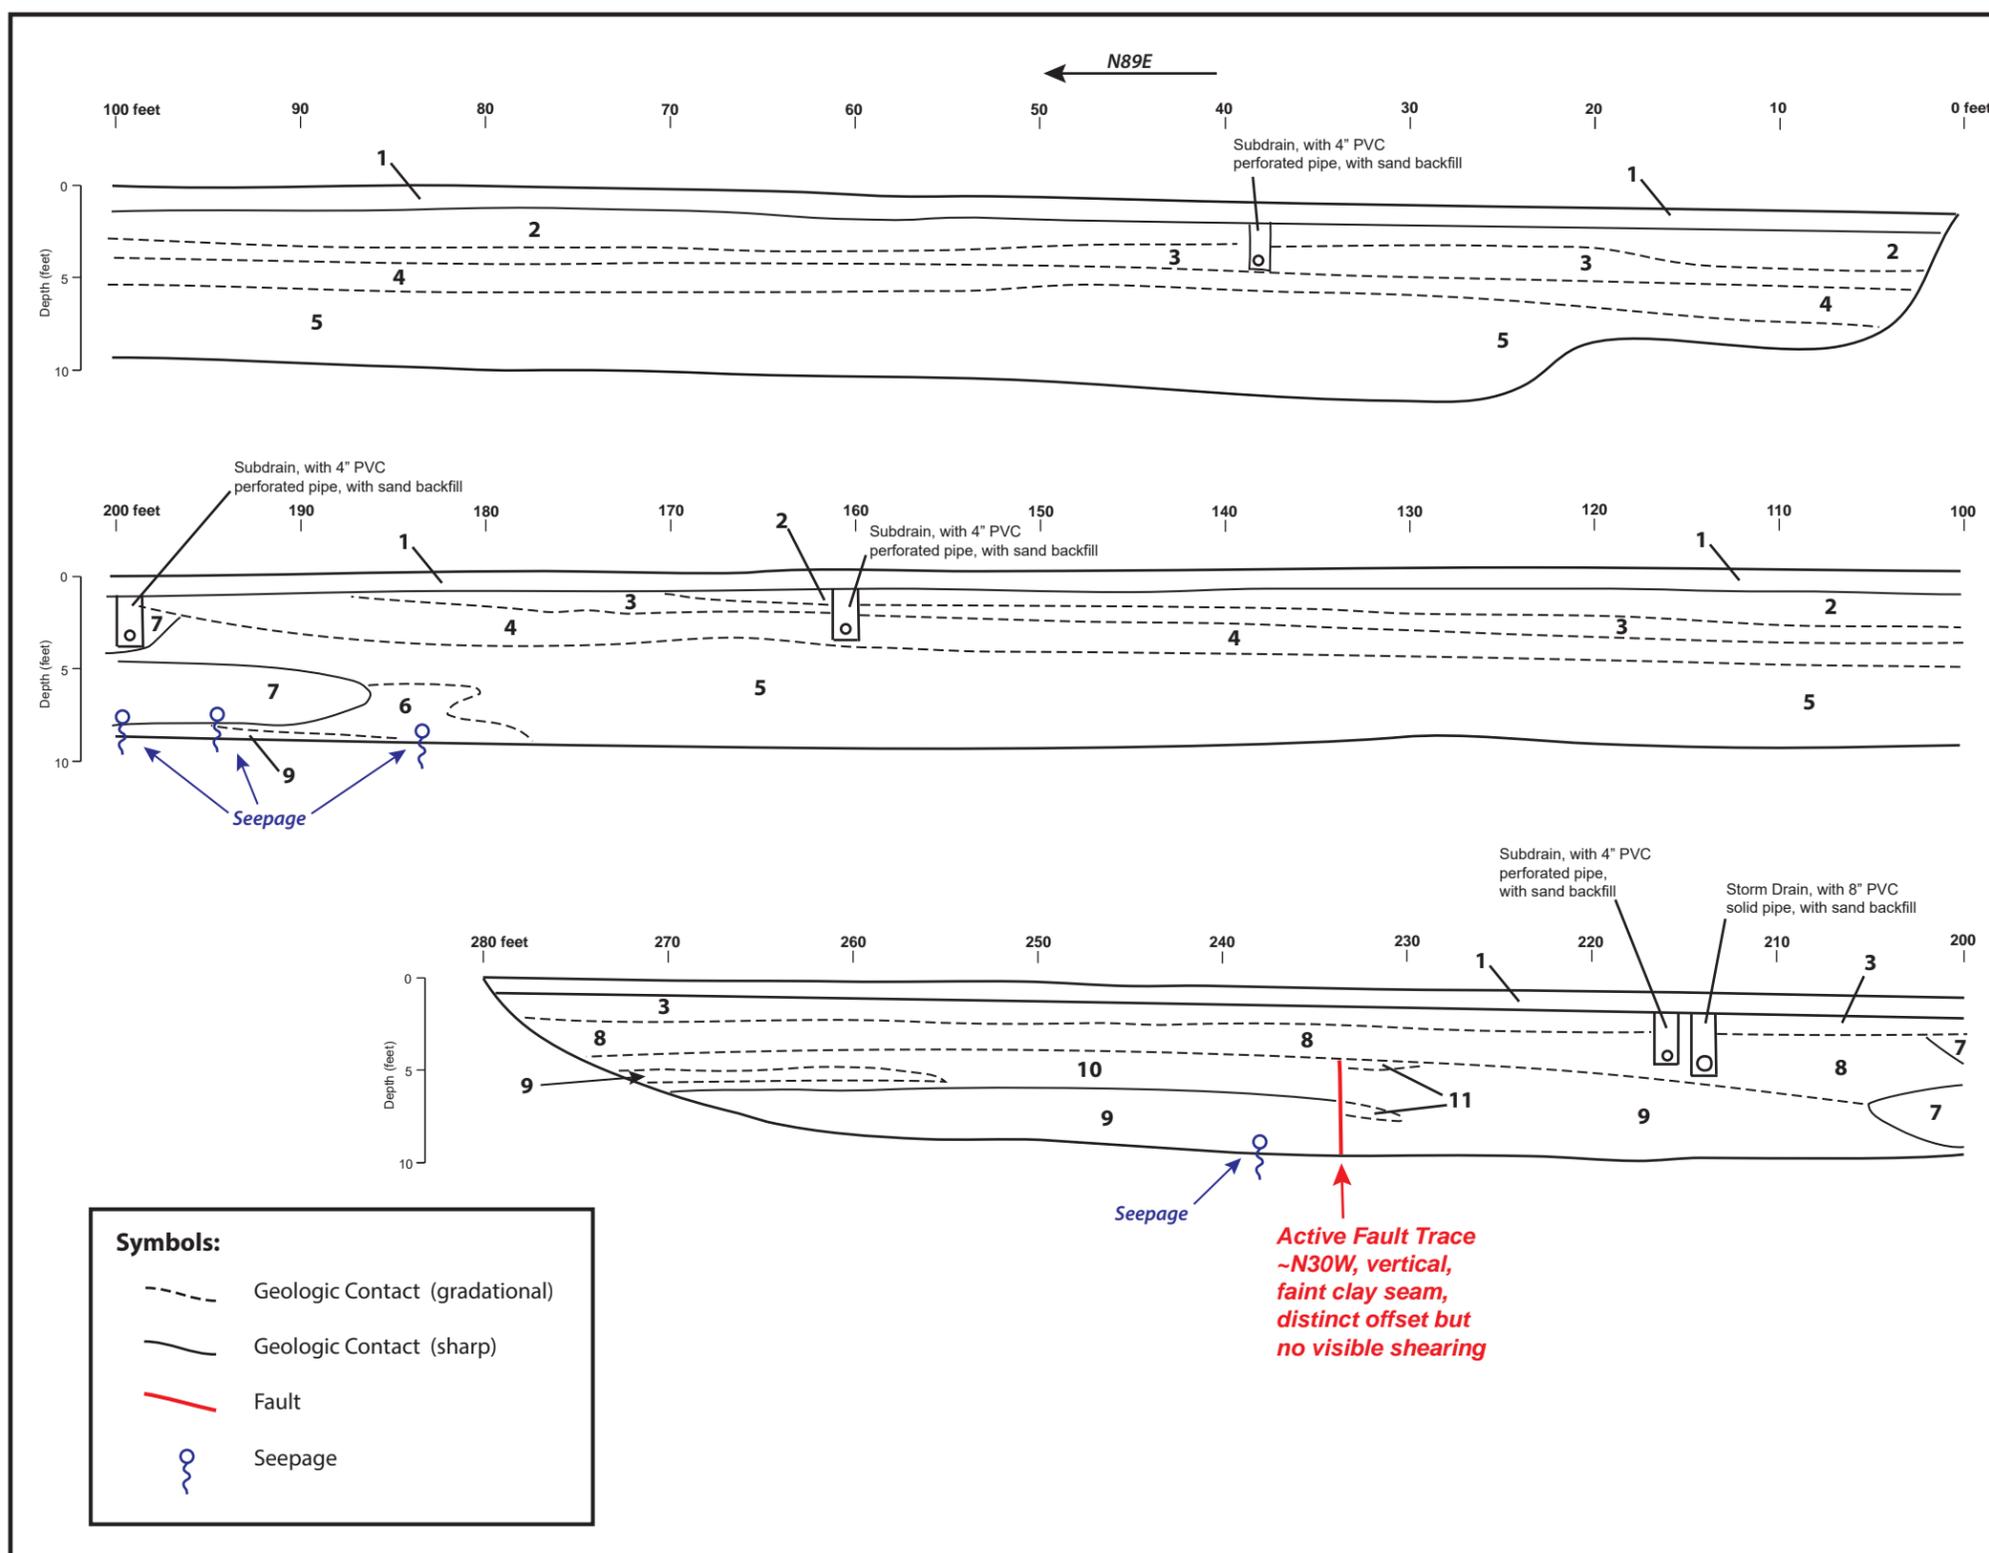
FIGURE **6**

In order to more precisely establish the location of active fault traces within the subject site, we performed an exploratory trench near the southern site margin, as shown on Figure 2. The trench was excavated on July 11–12, 2020, and logging was performed on July 13–15. The trench was loosely backfilled and track-walked on July 18th. The excavation and backfilling operations were performed by Engineered Soil Repairs of Walnut Creek, California. We should note that the trench backfill will need to be re-excavated and properly compacted prior to site development.

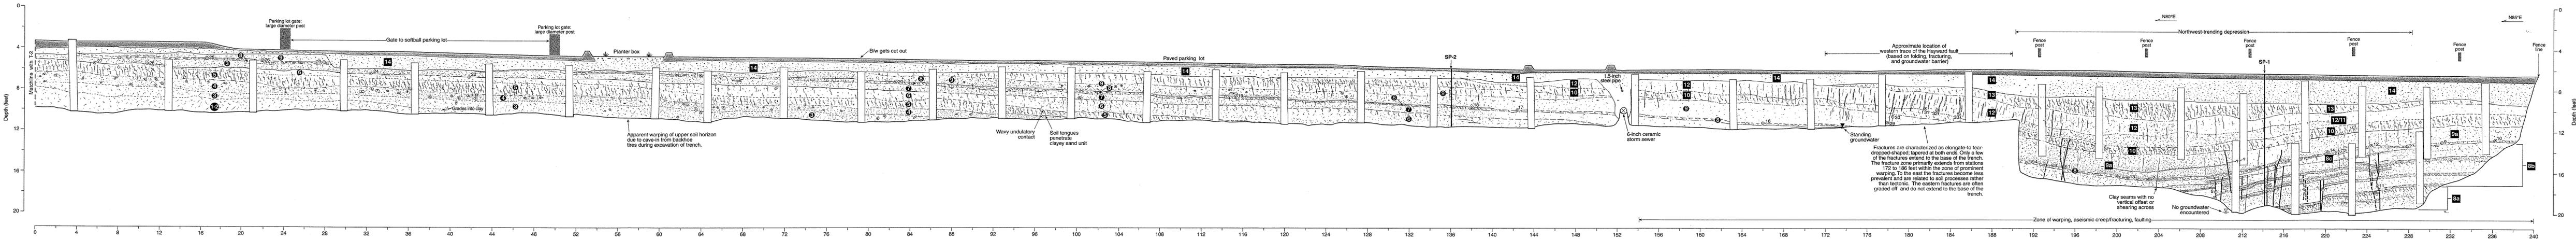
Figure D-1

William Lettis and Associates (WLA, 2003) performed an extensive fault investigation of the El Portal School property. The investigation included two exploratory trenches, with a total length of 408 feet in length, which crossed both the eastern and western Fault traces. In general, evidence of the fault traces in the trench was fairly subtle, although indications of faulting were observed in the locations of the eastern and western fault traces. In addition, the study found that soil layers within the area between the fault traces have been bowed upward by fault movement, forming a feature referred to as a pressure ridge. This upward bowing of the soil units corresponds to the area where a low mound was observed on older aerial photographs. The locations of the trenches are shown on Figure 2 and trench logs are presented in Appendix D.
